## Scheme, Access road flooding, investigation, design and deliver solution.

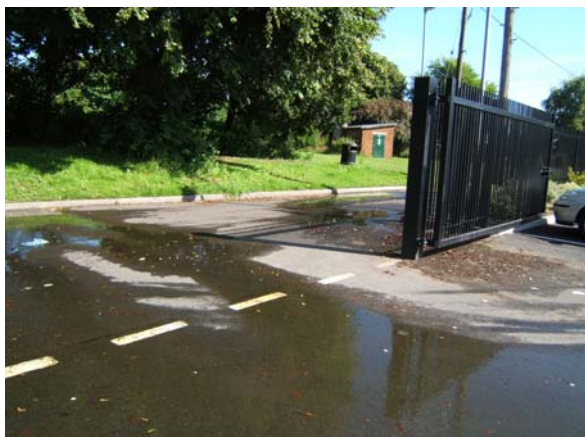
This access road to a NHS Trust Clinic suffered from flooding due to water coming up out of the road gullies. We discovered this was due to the original collapsed connection to a railway drain being replaced by a soakaway. After a few years the soakaway had become inundated so water from higher ground could only find its way up and out of these gullies. New building work meant it was no longer possible to repair the old pipe. The flooding was dangerous for vehicles and pedestrian getting to and from the clinic, particularly in the winter.

Following a full investigation I proposed several solutions, and after consultation with all stakeholders it was decided to make a direct connection to the old drain at the top of the railway embankment, if we could find it! If not we have to construct an outfall to the abandoned railway. I produced a detailed scheme drawing, specification document and a schedule of rates to quote against. I was then asked to fully supervise the work of the successful contractor, we laid 95m of new drain, found the old drain and made a connection, building an new manhole on the junction. The scheme was finished ahead of schedule, on budget, and there have been no flooding incidents since.
